PHOTOGRAPHIC INTERPRETATION REPORT

**CHRONOLOGY OF THE MISSILE  
AND SPACE DEVELOPMENT CENTER  
KALININGRAD 88  
MOSKVA, USSR**

JUNE 1967  
COPY 116  
9 PAGES

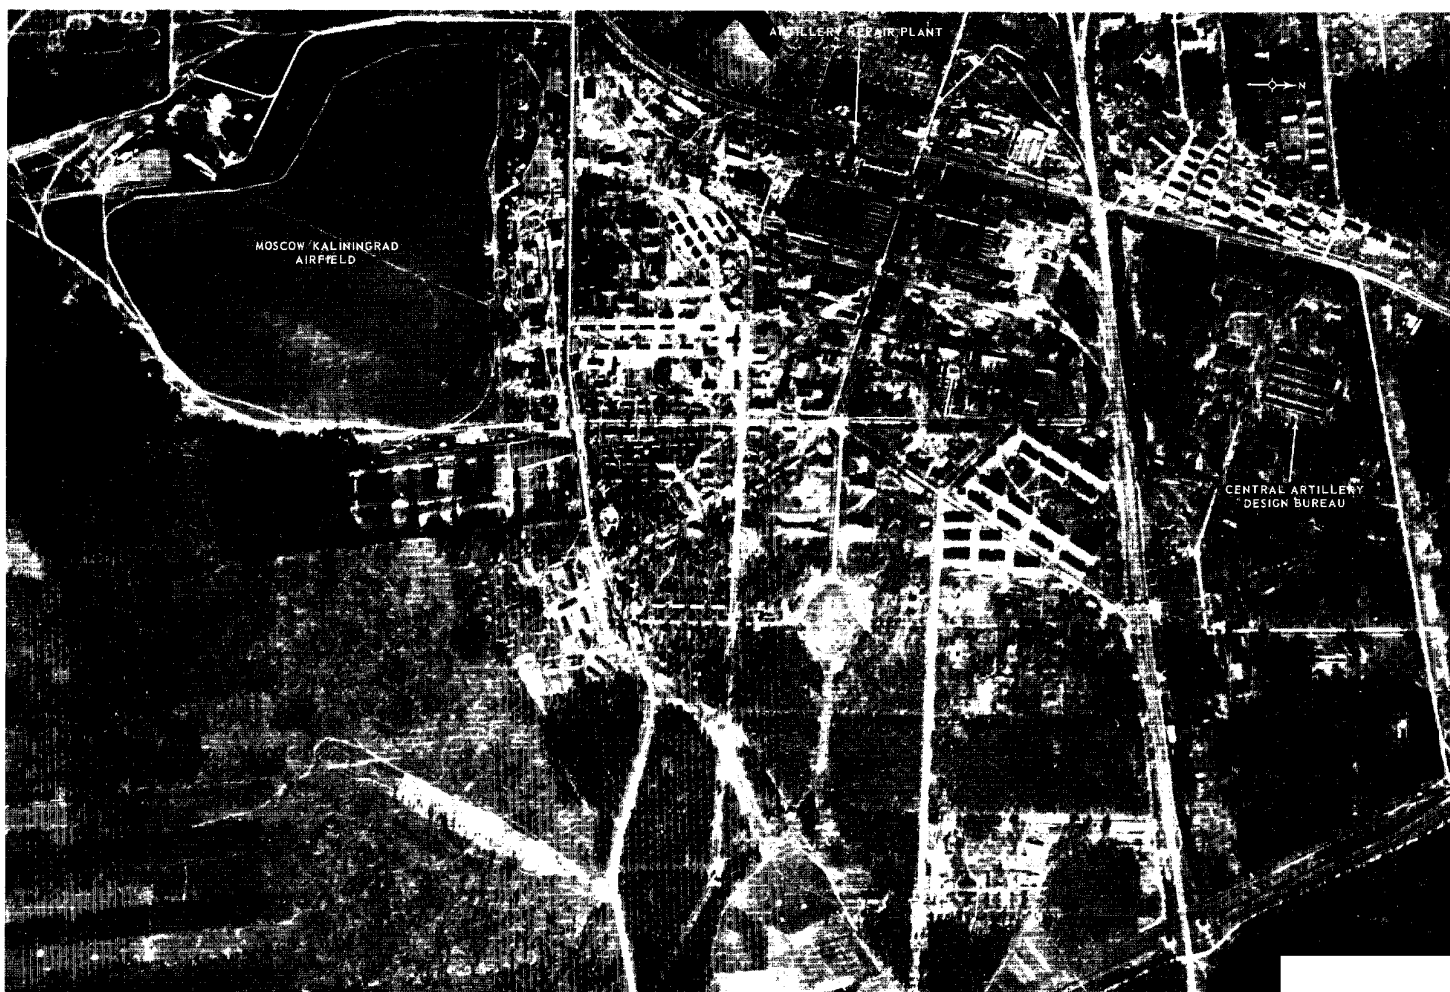
FIGURE 2. SITE OF MISSILE AND SPACE DEVELOPMENT CENTER KALININGRAD 88, MOSKVA, USSR

Parts of the site of the present center were once occupied by an artillery repair plant, the Central Artillery Design Bureau, and Moscow/Kaliningrad Airfield (Figure 2). Presently the center is divided into 4 separately secured facilities, 3 of which are contiguous (Figure 3): Missile Plant No 88 (Post Box 924), the Central Design Bureau for Space and Intercontinental Rockets (Post Box 651), Scientific Research Institute No 88 (NII 88; Post Box 989), and a horizontal static test facility. For purposes of simplicity, these facilities will be called Plant 88, the Design Bureau, NII 88, and the Horizontal Test Facility throughout the rest of the report.
